EXPERIMENTAL STUDY OF THE REINFORCED CONCRETE CONTINUOUS BEAMS EXTERNAL STRENGTHENED WITH CARBON FIBER REINFORCED PLATE

Cite this Article: Hassanien M. Thiyab and Hussein Raad Shaker, Experimental Study of the Reinforced Concrete Continuous Beams External Strengthened with Carbon Fiber Reinforced Plate, International Journal of Civil Engineering and Technology, 9(9), 2018, pp. 1766–1781.

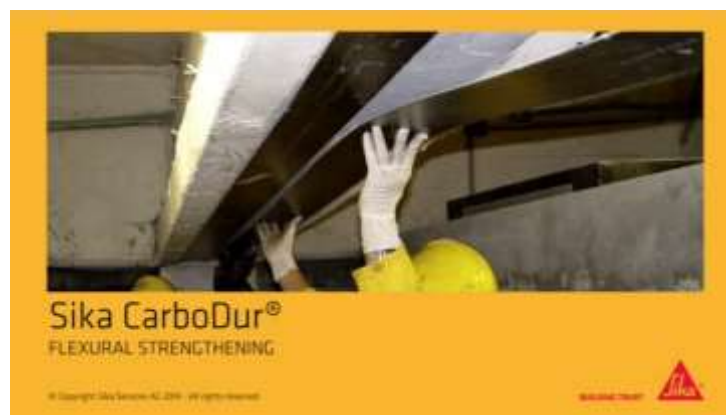
Figure 1 Carbon fiber reinforcement polymer plate.

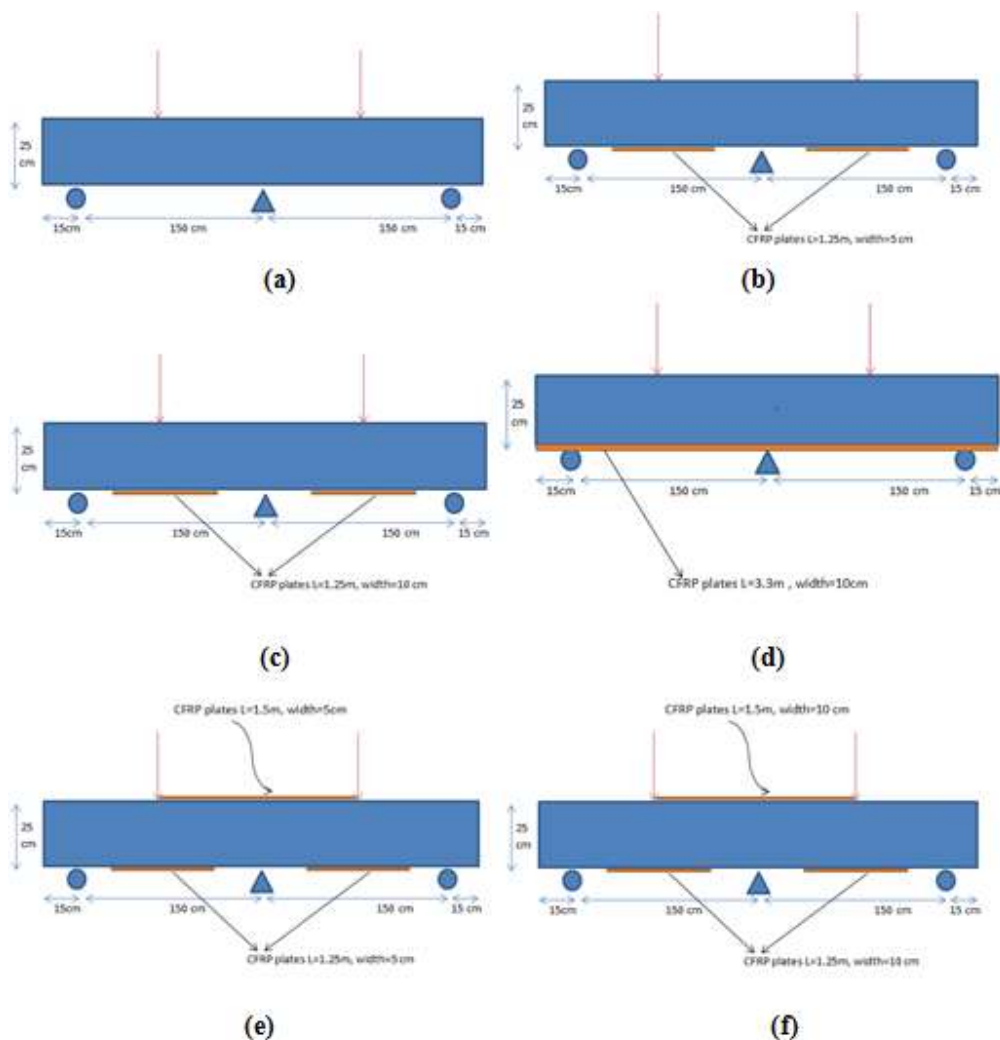
In the experimental study of this project include tested fifteen reinforcing concrete continuous beams, divided into three groups. Each group consist of five Rcc beams, first beam in each groups as controlled beam (un strengthened beam), second beam in each groups strengthened by CFRP plates with width 50 mm in positive zone in each span, third beam in each groups strengthened by CFRP plates with width 100 mm in positive zone in each span, fourth beam in each groups strengthened by CFRP plates with width 50 mm in positive and negative zone, fifth beam in each groups strengthened by CFRP plates with width 100 mm in positive and negative zone. Figure (2) show the strengthening system for beams.

Figure 2 strengthening system for beams (a) G11, G21, G31. (b) G12, G22, G32. (c)G13, G33. (d) G23. (e) G14, G24, G34. (f) G15, G25, G35.

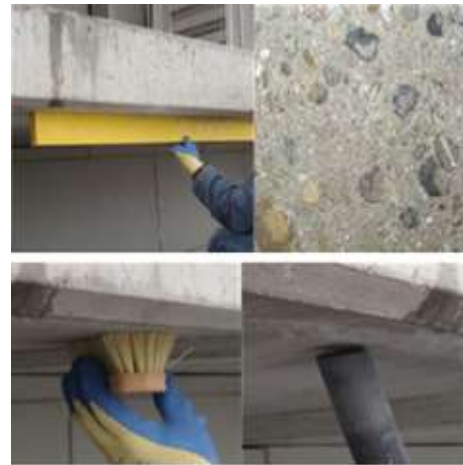
After 28 days from casting and curing the beams, cleaning and smoothing of the surface of reinforced concrete beam by using a scraper machine and then washing the surface by water and then adding epoxy to plates to paste on concrete surface as shown in Figure(4), Figure(5), Figure(6), and Figure (7). The properties of carbon fiber reinforced polymer and epoxy shown in Table (1) and Table (2).

Figure 5 Surface leveling, and cleaning

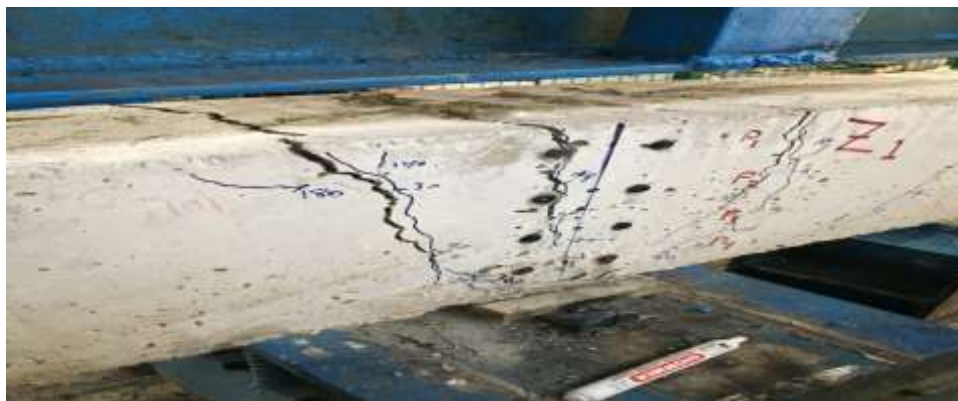
Beam G11 represent a controlled beam for group 1 and design to fail in flexural. When testing the specimen and applying the load the beam failed by flexure, the first crack is

appear at negative zone when the load was about of 30 KN. In the next stages of applying load, the crack was appeared in the positive zone of continuous beam to fail in flexural in this zone at ultimate load was about of 185 KN. The patterns crack of this beam was shown in Figure (9).

Figure 9 The patterns crack of beam G11.

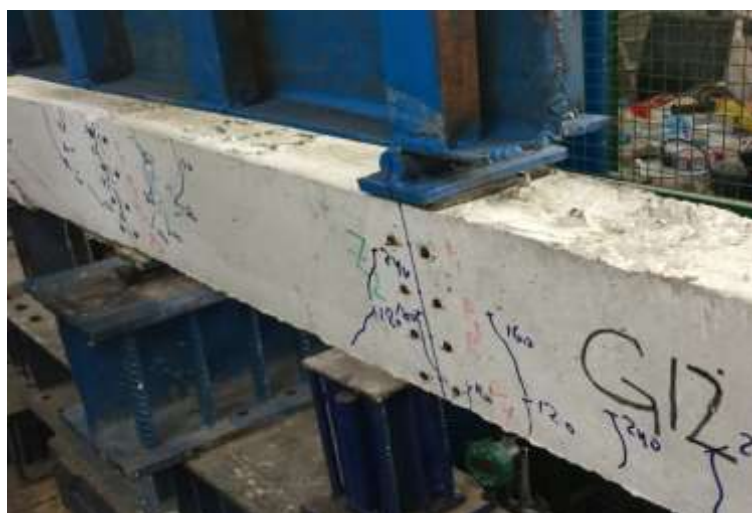
This beam was strengthened by carbon fiber reinforced polymer plates (CFRP plates) at positive moment zone from each span with width 50 mm of plate. When testing the specimen and applying the load the beam failed by flexure and peeling of CFRP plates with cover of concrete at ultimate load was about of 280 KN. The first crack is appearing at negative zone when the load was about of 30 KN. In the next stages of applying load, the crack was appeared in the positive zone of continuous beam. The patterns crack of this beam was shown in Figure (10).

Figure 10 The patterns crack of beam G12.

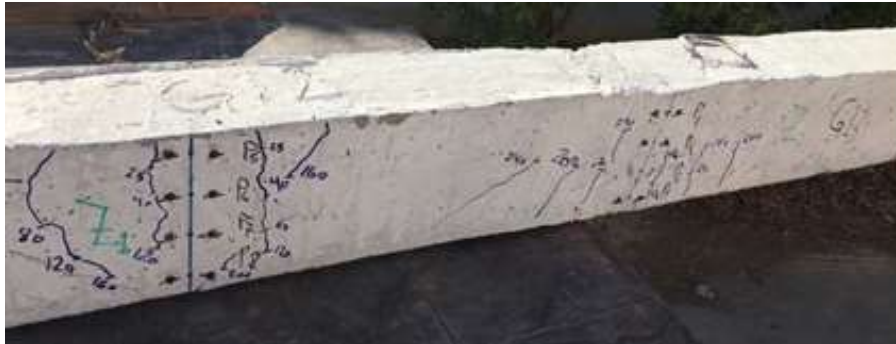
This beam was strengthened by carbon fiber reinforced polymer plates (CFRP plates) at positive moment zone from each span with width 100 mm of plate. When testing the specimen and applying the load the beam failed by flexure and peeling of CFRP plates with cover of concrete at ultimate load was about of 270 KN. the first crack is appear at negative zone when the load was about of 40 KN. In the next stages of applying load, the crack was

appeared in the positive zone of continuous beam and then fails. The patterns crack of this beam was shown in Figure (11).

Figure 11 The patterns crack of beam G13.

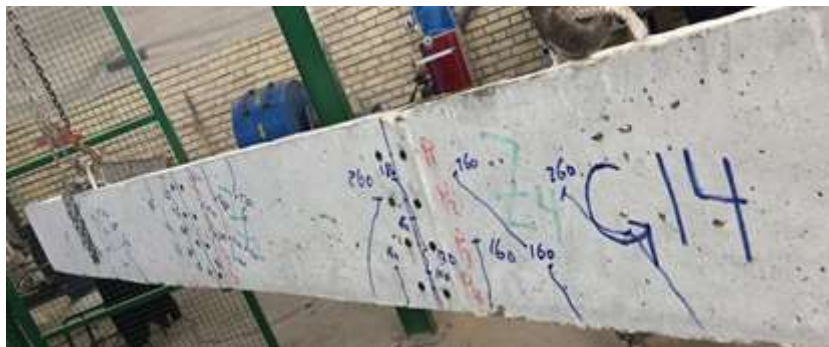
This beam was strengthened by carbon fiber reinforced polymer plates (CFRP plates) at positive moment zone from each span and negative moment zone with width 50 mm of plate. When testing the specimen and applying the load the beam failed by flexure and peeling of CFRP plates with cover of concrete at ultimate load was about of 290 KN. the first crack is appear at negative zone when the load was about of 30 KN. In the next stages of applying load, the crack was appeared in the positive zone of continuous beam and then fails. The patterns crack of this beam was shown in Figure (12).

Figure 12 The patterns crack of beam G14.

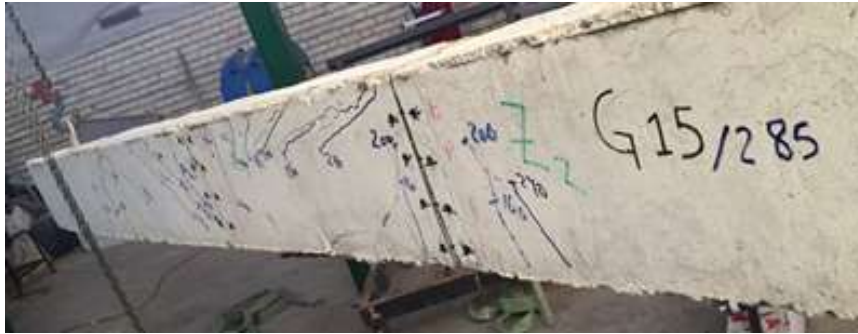
This beam was strengthened by carbon fiber reinforced polymer plates (CFRP plates) at positive moment zone from each span and negative moment zone with width 100 mm of plate. When testing the specimen and applying the load the beam failed by flexure and peeling of CFRP plates with cover of concrete at ultimate load was about of 285 KN. the first crack is appear at negative zone when the load was about of 40 KN. In the next stages of applying load, the crack was appeared in the positive zone of continuous beam and then fails. The patterns crack of this beam was shown in Figure (13).

Figure 13 The patterns crack of beam G15.

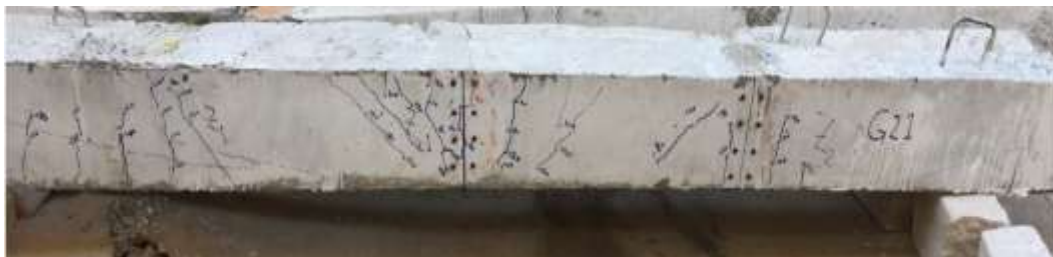
Beam G21 represent a controlled beam for group 2 and design to fail in flexural. When testing the specimen and applying the load the beam failed by flexure, the first crack is appear at negative zone when the load was about of 40 KN. In the next stages of applying load, the crack was appeared in the positive zone of continuous beam to fail in flexural at ultimate load was about of 250 KN. The patterns crack of this beam was shown in Figure (14).

Figure 14 The patterns crack of beam G21.

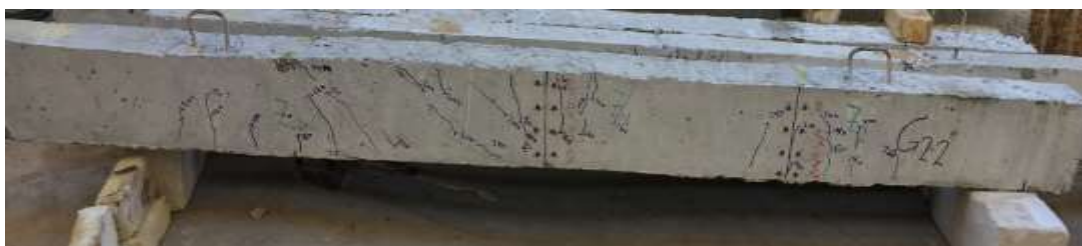
This beam was strengthened by carbon fiber reinforced polymer plates (CFRP plates) at positive moment zone from each span with width 50 mm of plate. When testing the specimen and applying the load the beam failed by flexure and peeling of CFRP plates with cover of concrete at ultimate load was about of 310 KN. the first crack is appear at negative zone when the load was about of 50 KN. In the next stages of applying load, the crack was appeared in the positive zone of continuous beam and then fails. The patterns crack of this beam was shown in Figure (15).

Figure 15 The patterns crack of beam G22.

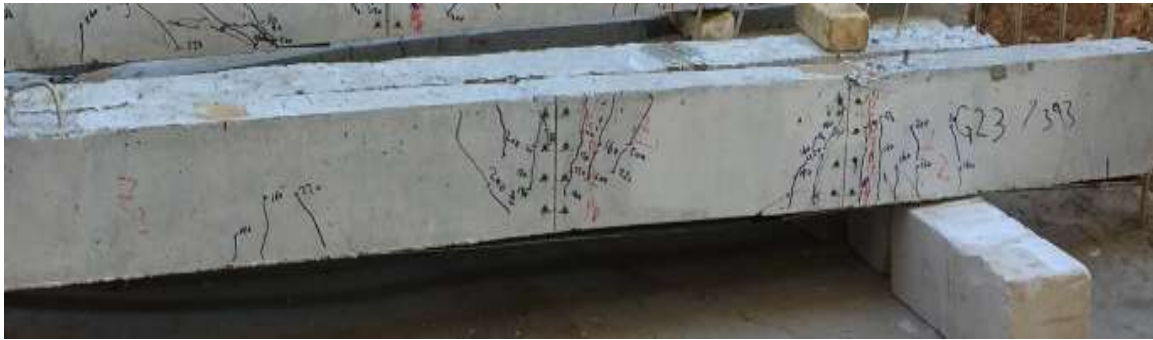
This beam was strengthened by carbon fiber reinforced polymer plates (CFRP plates) at along the bottom of beam with width 100 mm of plate. When testing the specimen and applying the load the beam failed by rupture of CFRP plates at ultimate load was about of 370 KN. the first crack is appear at negative zone when the load was about of 80 KN. In the next stages of applying load, the crack was appeared in the positive zone of continuous beam and then fails by rupture of CFRP plates. The patterns crack of this beam was shown in Figure (16).

Figure 16 The patterns crack of beam G23.

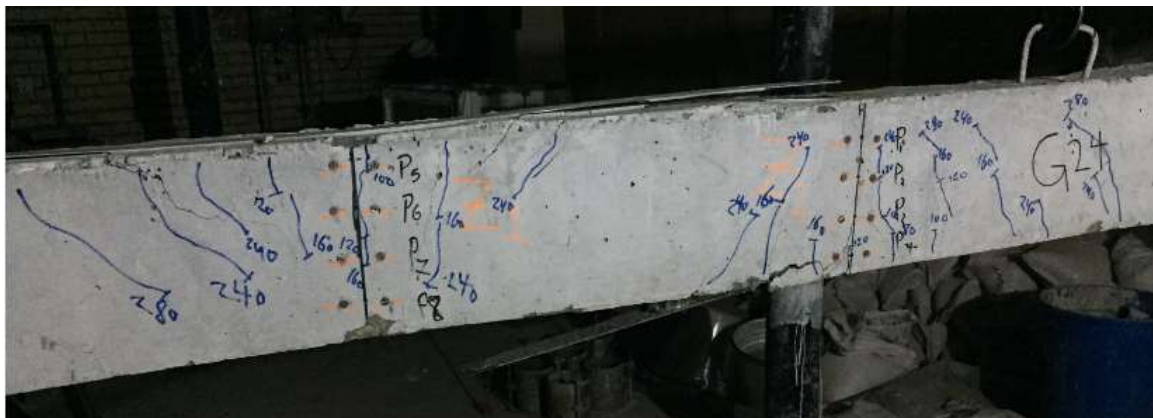
This beam was strengthened by carbon fiber reinforced polymer plates (CFRP plates) at positive moment zone from each span and negative moment zone with width 50 mm of plate. When testing the specimen and applying the load the beam failed by flexure and peeling of CFRP plates with cover of concrete at ultimate load was about of 320 KN. the first crack is appear at negative zone when the load was about of 100 KN. In the next stages of applying load, the crack was appeared in the positive zone of continuous beam and then fails. The patterns crack of this beam was shown in Figure (17).

Figure 17 The patterns crack of beam G24.

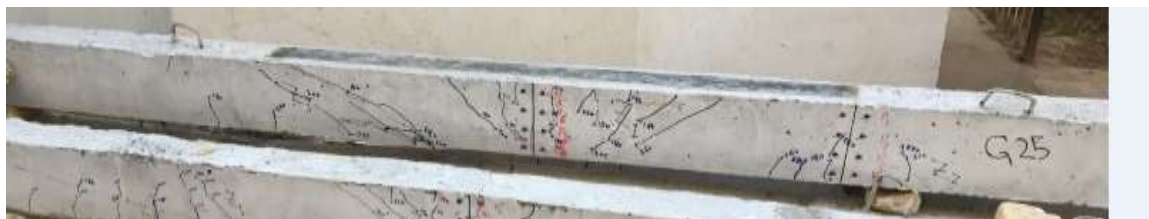
This beam was strengthened by carbon fiber reinforced polymer plates (CFRP plates) at positive moment zone from each span and negative moment zone with width 100 mm of plate. When testing the specimen and applying the load the beam failed by flexure and peeling of CFRP plates with cover of concrete at ultimate load was about of 300 KN. the first crack is appear at negative zone when the load was about of 60 KN. In the next stages of

applying load, the crack was appeared in the positive zone of continuous beam and then fails. The patterns crack of this beam was shown in Figure (18).

Figure 18 The patterns crack of beam G25.

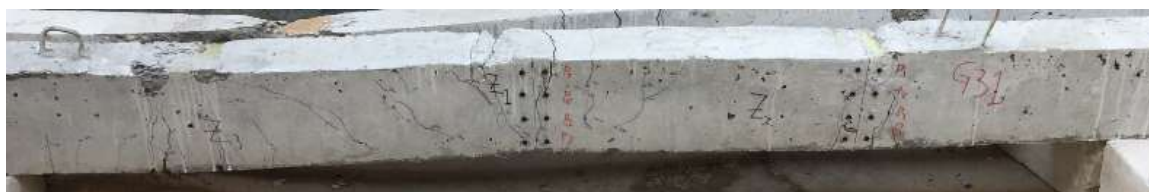
Beam G31 represent a controlled beam for group 3 and design to fail in flexural. When testing the specimen and applying the load the beam failed by flexure, the first crack is appear at negative zone when the load was about of 40 KN. In the next stages of applying load, the crack was appeared in the positive zone of continuous beam to fail in flexural at ultimate load was about of 210 KN. The patterns crack of this beam was shown in Figure (19).

Figure 19 The patterns crack of beam G31.

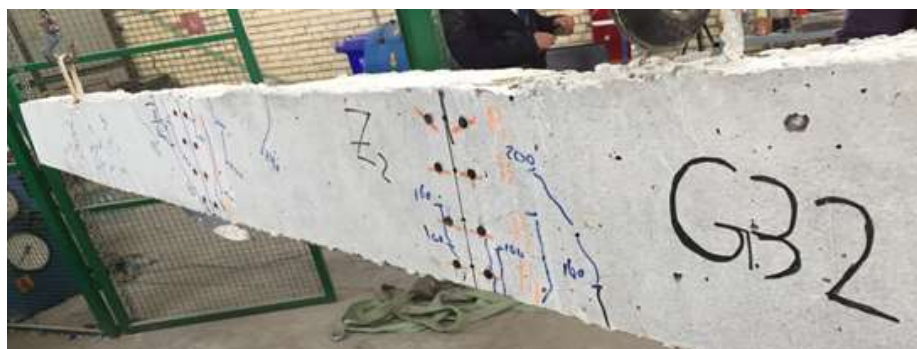
This beam was strengthened by carbon fiber reinforced polymer plates (CFRP plates) at positive moment zone from each span with width 50 mm of plate. When testing the specimen and applying the load the beam failed by de bonding of CFRP plates from concrete surface at ultimate load was about of 260 KN. the first crack is appear at negative zone when the load was about of 80 KN. In the next stages of applying load, the crack was appeared in the positive zone of continuous beam and then fails. The patterns crack of this beam was shown in Figure (20).

Figure 20 The patterns crack of beam G32.

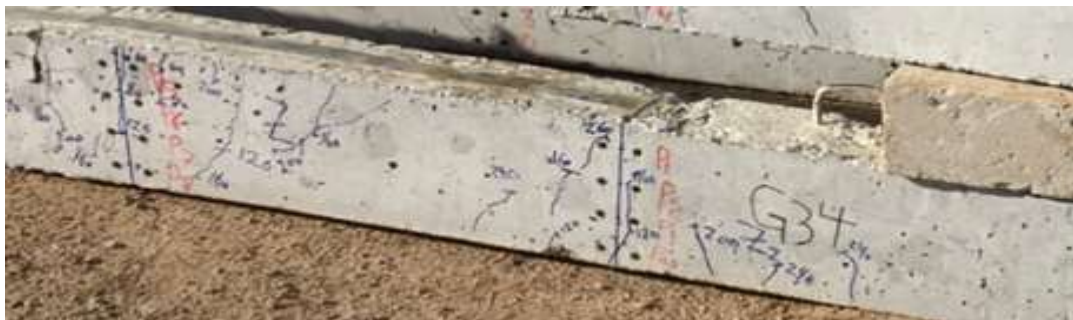
This beam was strengthened by carbon fiber reinforced polymer plates (CFRP plates) at positive moment zone from each span and negative moment zone with width 50 mm of plate. When testing the specimen and applying the load the beam failed by flexure and peeling of CFRP plates with cover of concrete at ultimate load was about of 273 KN. the first crack is appear at negative zone when the load was about of 40 KN. In the next stages of applying load, the crack was appeared in the positive zone of continuous beam and then fails. The patterns crack of this beam was shown in Figure (22).

Figure 22 The patterns crack of beam G34.

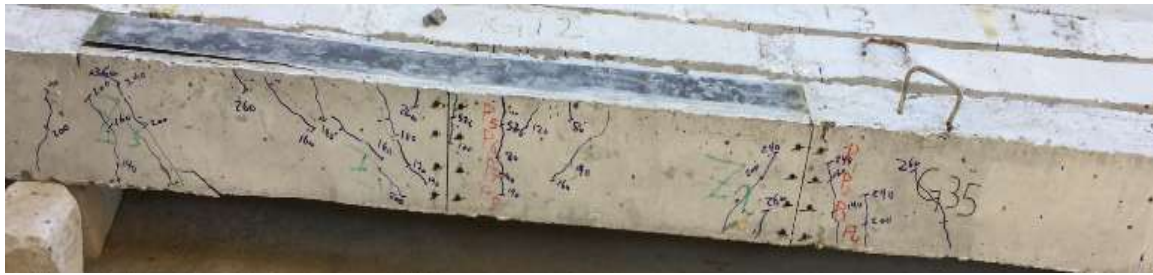
This beam was strengthened by carbon fiber reinforced polymer plates (CFRP plates) at positive moment zone from each span and negative moment zone with width 100 mm of plate. When testing the specimen and applying the load the beam failed by flexure and peeling of CFRP plates with cover of concrete at ultimate load was about of 280 KN. the first crack is appear at negative zone when the load was about of 60 KN. In the next stages of applying load, the crack was appeared in the positive zone of continuous beam and then fails. The patterns crack of this beam was shown in Figure (23).

Figure 23 The patterns crack of beam G35.

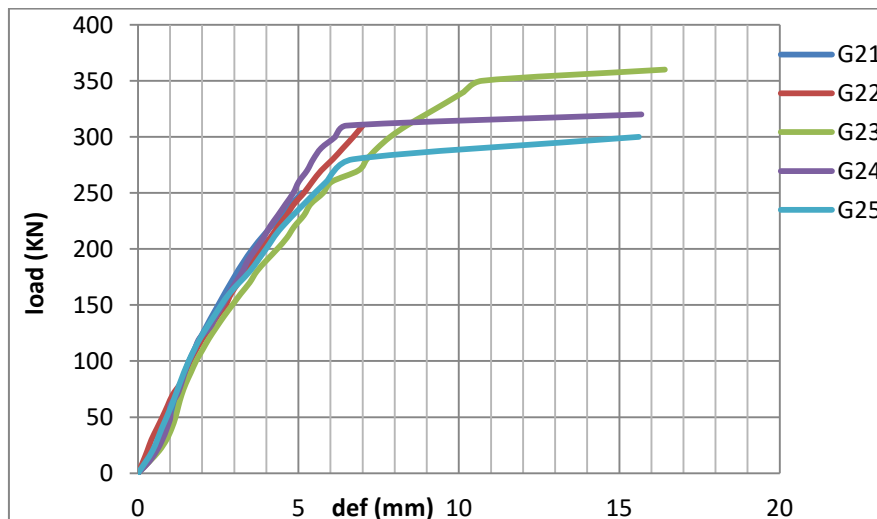
Figure 25 load-deflection curve for Group 2 (G2).

Load-deflection curve for group one shown in figure(24), load-deflection curve for group two shown in figure(25), and load-deflection curve for group three shown in figure(26). And load- crack width curve for group one shown in figure(27), load- crack width curve for group two shown in figure(28), and load- crack width curve for group three shown in figure(29).
