ENHANCING THE MACHINING PERFORMANCE OF HSS DRILL IN THE DRILLING OF GFRP COMPOSITE BY REDUCING TOOL WEAR THROUGH WEAR MECHANISM MAPPING

Cite this Article: Dr. U. Sathish Rao and Dr. Lewlyn L.R. Rodrigues. Enhancing the Machining Performance of HSS Drill in the Drilling of GFRP Composite by Reducing Tool Wear through Wear Mechanism. *International Journal of Mechanical Engineering and Technology*, 8(1), 2017, pp. 120–131.

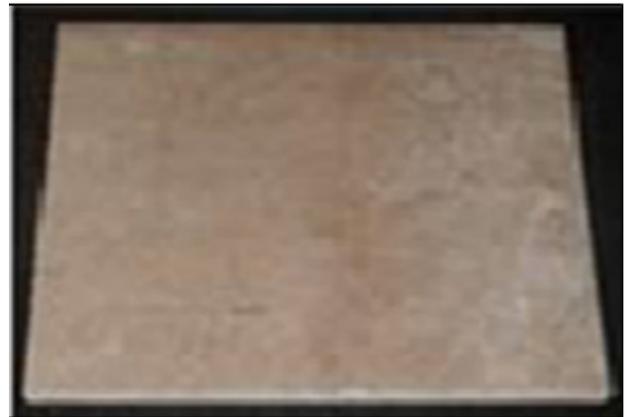
Figure 2 Schematic of hand lay-up technique

The GFRP composite laminate was fabricated to a fiber weight fraction of 33% by mixing approximately 2 kilogram of Isophthalic polyester resin with 1 kg of randomly oriented structural glass reinforcement and the hardener (Poly Ether Ether Ketone). Laminate sample with dimension of 600×600×10 mm was fabricated using hand lay-up process (Figure 1). The laminate was hardened under atmospheric temperature and pressure conditions for a period of 24 hours. The properties of the GFRP composite are listed in Table 1. The GFRP composite laminate after the fabrication and atmospheric curing is shown in Figure 2.

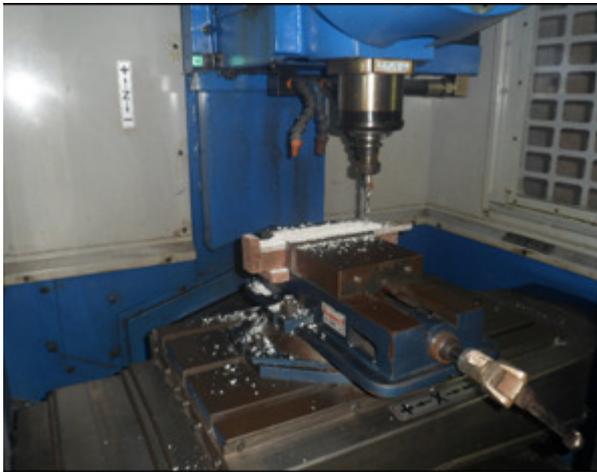
In order to maintain accuracy and data reliability, the drilling operation on the GFRP composite was carried out on Computer Numerical Controlled (CNC) Vertical Machining Center (VMC) (Figure 3). During machining, 80 holes of 6 mm diameter were drilled on the GFRP composite laminate using uncoated HSS twist drill (Figure 4). The drilled holes are spaced on the composite laminate as per the drill hole specifications and standards for fasteners. The spindle speed varied from 1200 rpm (cutting speed = 22.62 m/min) to 1800 rpm (cutting speed = 33.93 m/min) while the feed rate is varied from 0.1 mm/rev to 0.3 mm/rev as shown in Table 3. Each experimental run was designed with different parameters by applying the Design of Experiments (DoE) concept as shown in Table 1.

Figure 3 VMC performing drilling on composite laminate **Figure 4** HSS drills of diameter 6, 8 and 10mm

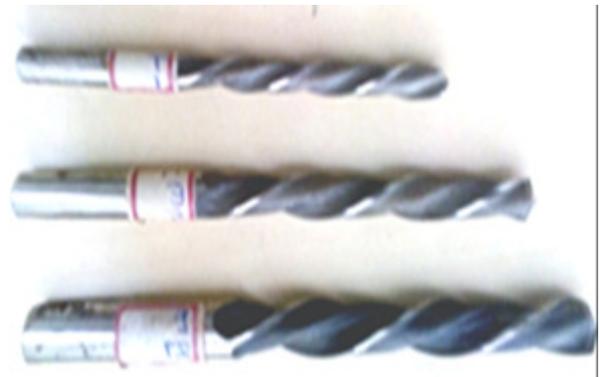
The wear mechanism / transition map of uncoated HSS drills of 8mm diameter, machining GFRP composite laminates is constructed through the wear data collection. The wear data is collected through experimental work, carried out by considering drilling process parameters at different levels. The GFRP laminate is manufactured for a constant thickness of 10mm and is used for machining operation. Bosch manufactured uncoated HSS drills of 6 mm diameter (refer Table 2 for specifications) was used for drilling in dry run condition.

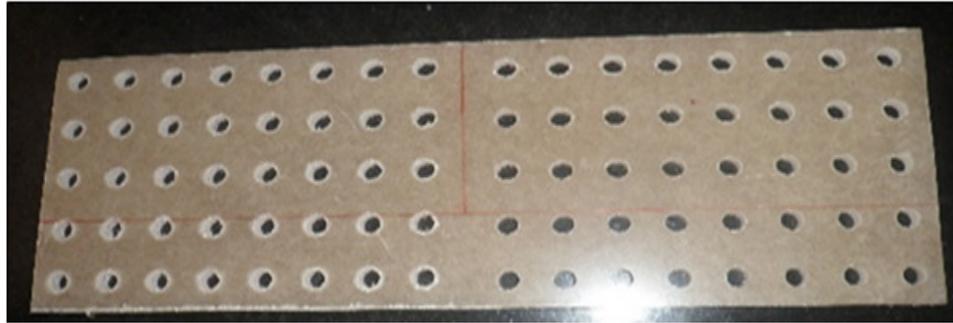
Figure 5 GFRP laminate with 80 holes drilled

After drilling 80 holes on the GFRP composite laminate, as shown in Figure 5.1, the drills were placed under the focus of Inverted Trinocular metallurgical microscope (Figure 5.2) to capture the micrograph images with a magnification factor of 500X to study and plot different wear mechanisms.

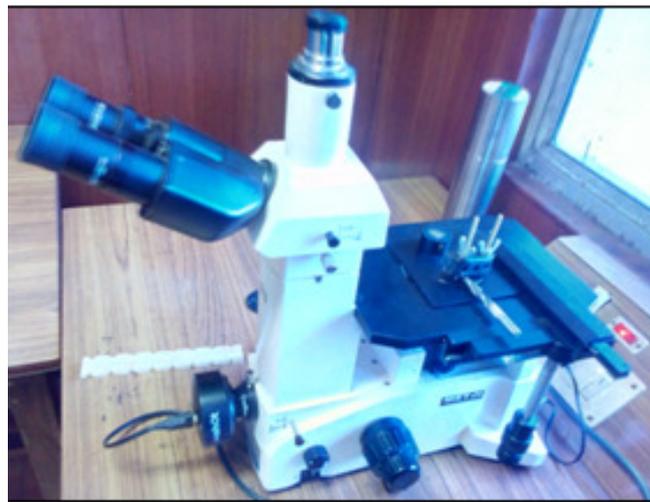
Figure 6 Trinocular Inverted Metallurgical microscope

Figure 6 show the Inverted Trinocular Metallurgical Microscope for surface morphology analysis. The drills were accurately held in a fixture in a proper position while capturing the images of the drill land and chisel edge areas. The captured images were interfaced and stored in the computer with the help of ENVISION software.

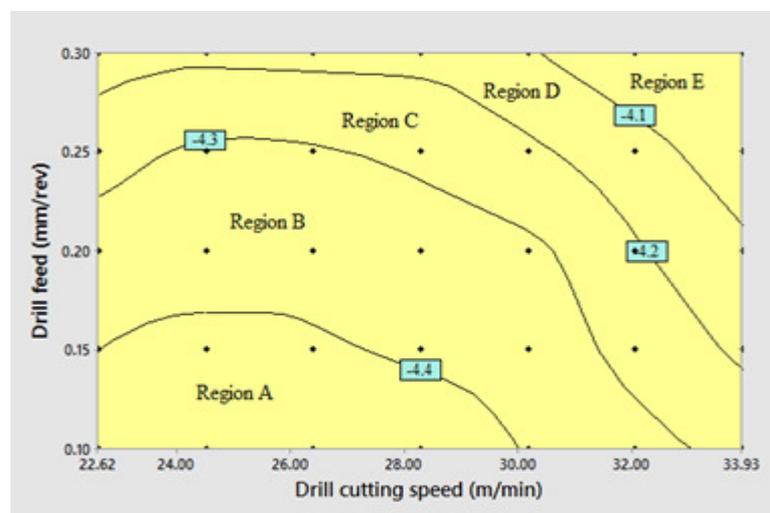
Figure 7 Wear rate map of 6mm HSS drill machining GFRP composites

Figure 7 shows the wear rate map of uncoated HSS tool of 6mm drill under dry machining of GFRP composite laminates. The wear rate map was plotted by taking the drill cutting speed as abscissa and the drill feed rate as ordinate. Different regions on the wear map were identified and demarcated where similar wear rates were obtained. For the present wear map study, five such regions were identified and were automatically demarcated using MINITAB software. The range of wear rate for each region was set as: -4.4 and below (Region A), -4.4 to -4.3 (Region B), -4.3 to -4.2 (Region C), -4.2 to -4.1 (Region D) and -4.1 and above (Region E). Rigorous examination of worn surfaces of the drill in different regions on the

wear rate map was done to identify the HSS drill wear mechanisms. The micrograph observations of the worn surfaces of drill land, chisel edge and flank area were taken with a magnification factor 500X for the microanalysis. The wear mechanisms were decided after examining a number of micrograph images with respect to each of the region and by considering the best among them.

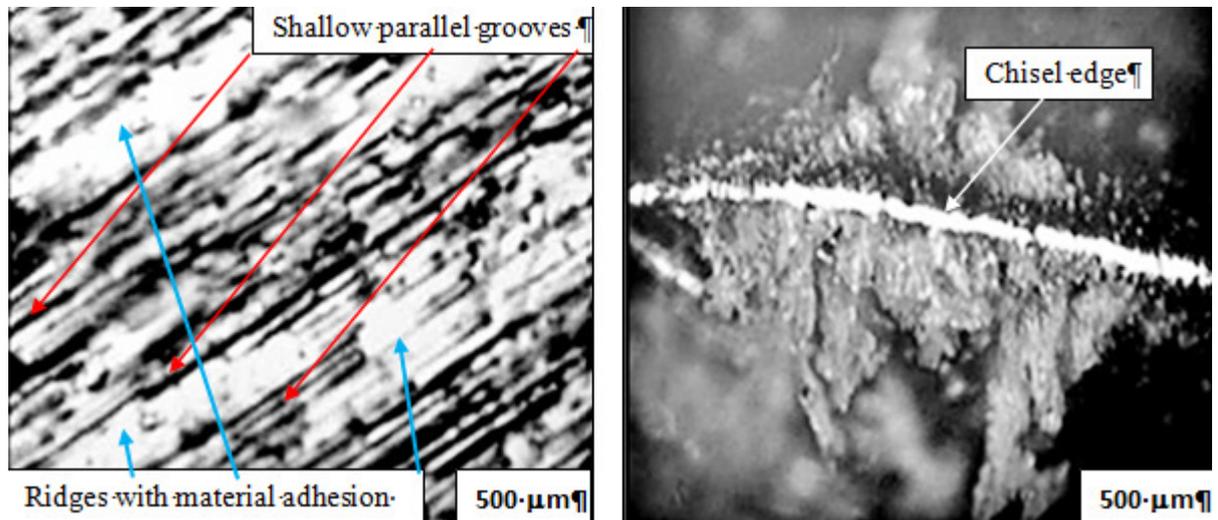
Figure 8 Composite adhering on to the 6mm HSS drill land and chisel edge

The micrograph images of the worn land surface of the drill for a feed rate of 0.15 mm/rev and cutting speed of 26.39 m/min (spindle speed=1400 rpm) is shown in Figure 8. The micrograph image in this Region A displayed the adhering of composite material on the drill land surface (left side image of Figure 8) and the chisel edge of the drill (right side image of Figure 8). A machined surface with shallow parallel grooves (red arrows) and uneven spreading of matrix material (polyester) transfer around the ridges on the land was observed (blue arrows). The micrograph image findings implied that, under this machining condition, the drill wear was governed by adhesion of work material on the drill land, which showed the presence of adhesive wear mechanism in region A.

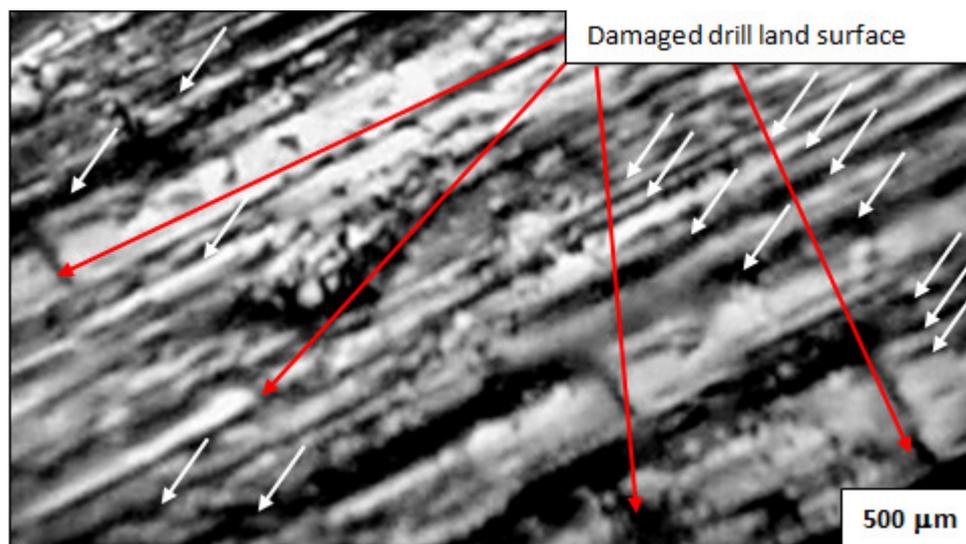
Figure 9 Worn land surface of the 6mm HSS drill under a feed rate of 0.2 mm/rev and at a cutting speed of 28.27m/min

Figure 9, shows the micrograph image of the worn drill land surface under Region B at a feed rate of 0.2 mm/rev and cutting speed of 28.27m/min (spindle speed=1500 rpm). The micrograph image displayed more transferred matrix metal and distribution of white lumps of matrix material over the surface area of the drill land. The red arrows in Figure 9 indicated the locations of the damaged and abraded ridges on the drill land surface. This is usually seen on those cutting tools suffering from abrasive wear mechanism (Zhang, 2001). So, a similar finding was observed here, with the GFRP composite material adhered on the ridges of the drill land. Along with this, the abraded and damaged parallel ridges (white arrows in Figure 9) confirmed a combination of adhesion and abrasion wear mechanism in region B.

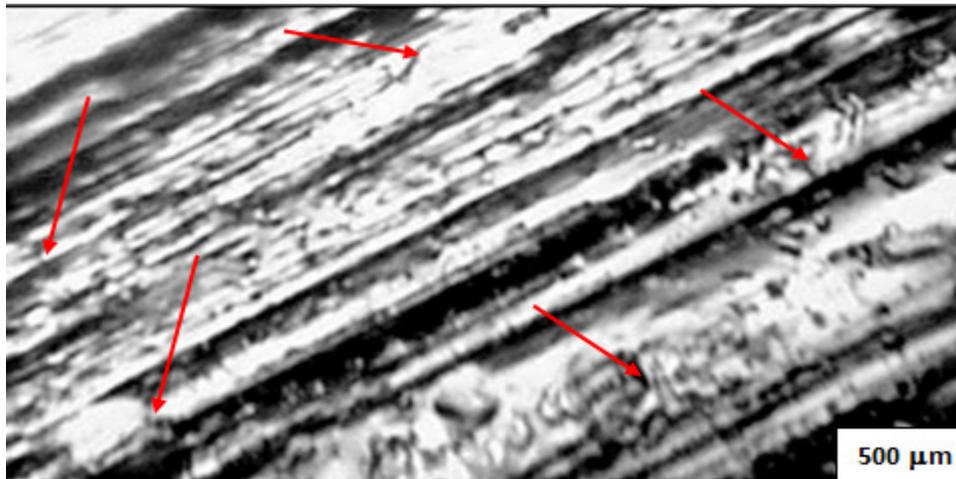
Figure 10 Worn land surface of 6mm HSS drill under a feed rate of 0.2 mm/rev & at a cutting speed of 30.16 m/min

The micrograph of the worn surface of the drill land under a feed rate of 0.25 mm/rev and a cutting speed of 30.16 m/min (spindle speed=1600 rpm) is observed in Figure 10. This machining condition was with respect to region C. The micrograph observations revealed parallel and deeper plowing grooves. Small cuts and damages were also observed on the edges of the grooves which are shown by the arrows in Figure 10. The random orientation of the fibers will cause uneven abrading of the surface they come across during machining. Thus the rough and uneven land surface demonstrated more abrasion i.e., more wear rate, compared to regions A and B. The more wear rate could also be due to the hardness and abrasive nature of the debonded glass fibers (especially silicon carbide present in glass). All these actions were reflected in the above micrograph image which confirmed more abrasion of the drill land surface and inferred that the abrasive wear is the major wear mechanism in region C.

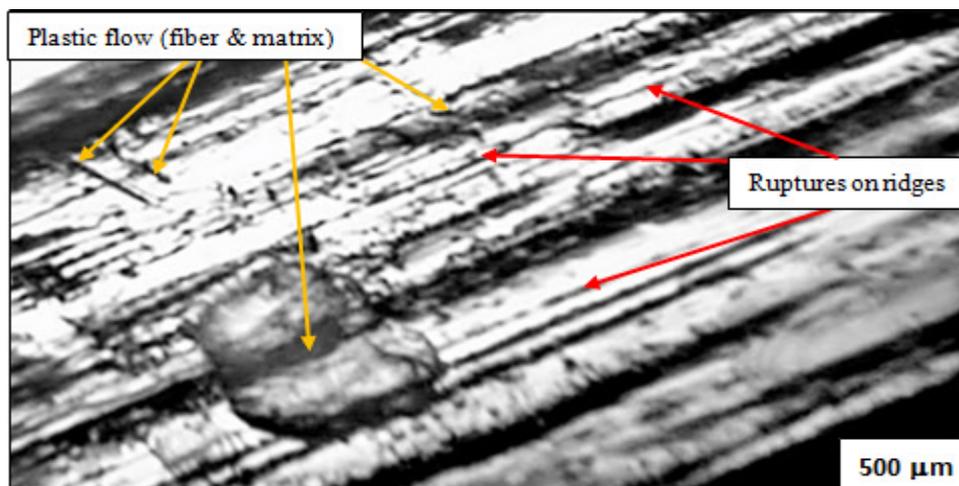
Figure 11 Worn land surface of 6mm HSS drill under a feed rate of 0.25 mm/rev & at a cutting speed of 32.04 m/min

Figure 11, shows the micrograph of the worn surface of cutting tool under a feed rate of 0.25 mm/min and a cutting speed of 32.04 m/min (spindle speed=1700 rev/min). At these high machining conditions (corresponding to Region D), the image revealed the presence of plastic flow of the matrix and fiber (shown by yellow arrows). The ruptured ridges, long and shallow cracks were also observed on the worn surface (red arrows). Thus the wear in region D could be due to the matrix melting and depositing at the tool work interface during machining. Therefore drilling in region D should be avoided to overcome the drill damage.

composites has links to the process of fiber debonding. The small cracks running on the drill land surface indicated the severe abrasion of the surface due to the rubbing action of the SiC particles as well as the debonded fibers from the matrix during machining (Figure 11). The micrograph findings also indicated that the regimes D and E were thermally sensitive and were temperature controlled regions with the wear rates of -4.2 to -4.1 and above -4.1 . The micrograph analysis also indicated that the wear mechanisms in these regimes could be plastic flow / fatigue wear and machining in these regimes must be avoided.

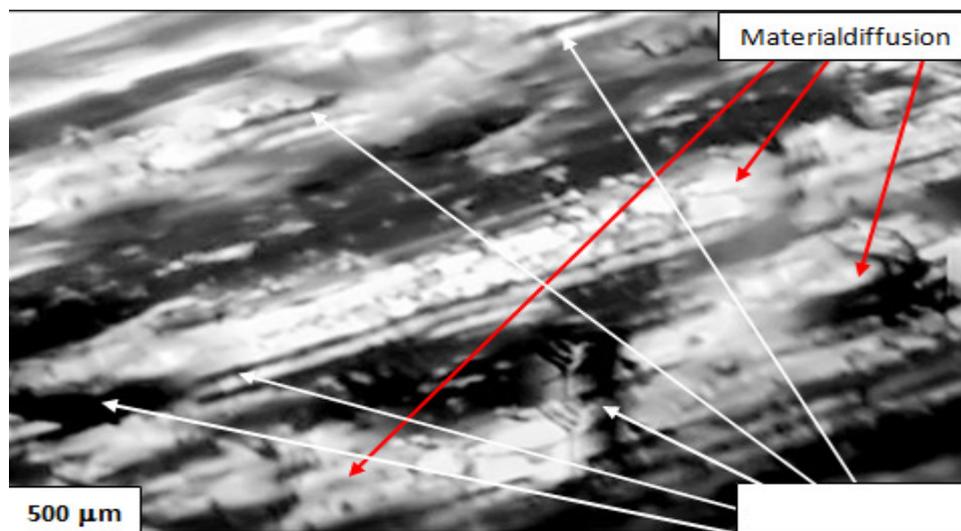
Figure 12 Worn land surface of 6mm HSS drill under a feed rate of 0.30 mm/rev and at a cutting speed of 34 m/min

Figure 12 shows the micrograph image of the worn surface of cutting tools under a feed rate of 0.3 mm/rev and a cutting speed of 34 m/min (spindle speed=1800 rev/min). More material transfer, diffusion were detected which could be due to the more frictional and thermal impact at the tool-work interface because of the increased level of machining factors. The worn surface in region E was also observed with small cracks. The land surface was composed of smooth waves and smudges of transferred material from the work piece. Figure 12 also showed small eroded slots.

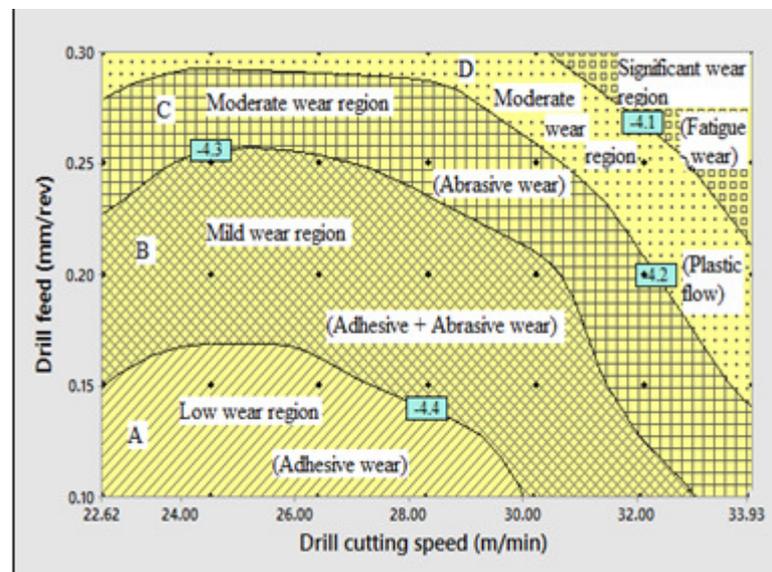
Based on this and the above micrograph observations, the wear mechanism map for 6 mm HSS drill during dry drilling of GFRP composite was developed and is shown in Figure 13. The wear mechanisms observed by the microscope images included adhesive wear, adhesive and abrasive wear, abrasive wear, plastic flow and thermal / fatigue wear. Closer examination of these mechanisms suggested that the plastic deformation controlled regimes/ zones included: the zone A, B and C with different wear rates of -4.4 to -4.2. Thus, the wear mechanisms under plastic deformation regions could be adhesive wear, adhesive and abrasive wear, and abrasive wear. From the micrographs also it could be seen that the major damage to the drill land occurred due to adhesion and abrasion. As shown in Figure 8 and other micrograph images, adherent work piece material progressively grew during the drilling process and the Silicon carbide present in the glass fibers were responsible for the abrading action on the surfaces of the drill. The thick layers of material were the indication of layering or overlapping. These were the indications of the extensive plastic deformation and shearing action experienced during drilling. The small cuts and the small scratch marks showed in micrograph (Figure 10) suggested that are markable amount of abrasion and plastic deformation took place during drilling. All these indications showed that the major wear mechanisms under the low machining conditions could be adhesion and abrasion wear mechanisms and to support this, these two mechanisms covered major area under the plastic deformation. Grooves of varying sizes were commonly observed throughout the examined worn surfaces. The formation of such grooves during the drilling of

Figure 13 Wear mechanism/transition map of 6mm HSS twist drill machining GFRP composites

Another important feature of the wear rate map was the presence of a “Safety region” or “Low-wear region” where the tool wear rate was observed to be the lowest. This indirectly informed that the wear rate of HSS drill during machining could be minimized by maintaining the levels of the process parameters within the safety zone boundary of the map, which might improve the tool performance and cutting tool life. In Figure 7, Region A had the lowest wear rate ranging from -4.4 and below, which could be named as “Safety zone”, for 6mm HSS drill machining GFRP composites. It was inferred that the life of the drill could be enhanced if the drilling parameters were made to operate within the range, of the “Safety zone” (Zhang, 2001, Wang, 2008). Thus, from Figure 13, for 6mm HSS drill, the process parameters corresponding to the “Safety zone / Low wear zone” were found to be:

Drill cutting speed: 22.62 m/min – 30 m/min (drill spindle speed = 1200 – 1590 rpm)

Drill feed rate: 0.10 – 0.17 mm/rev
